# Madsen Creek Flow and Water Quality Control Pond

## *Operations & Maintenance Manual*

September 2012

**Department of Natural Resources and Parks**  
Water and Land Resources Division  
Stormwater Services Section, Capital Services Unit  
201 South Jackson Street, Suite 600  
Seattle, Washington 98104-3855

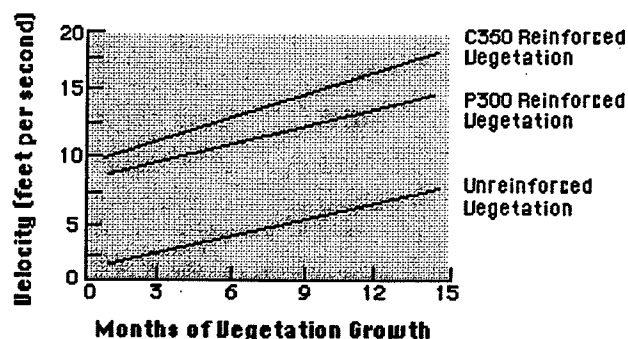
Estimated permissible velocities for natural and reinforced Kentucky bluegrass

Phase 2 occurs after seed germination and emergence and continues until the plants become full mature or established. There is a continued need for the TRM to provide erosion control at the base of the seedlings and for the interstitial soil surfaces between plants. The TRM must also provide structural support and reinforcement to prevent the plants with their undeveloped root and vegetative structures from being plucked from the soil.

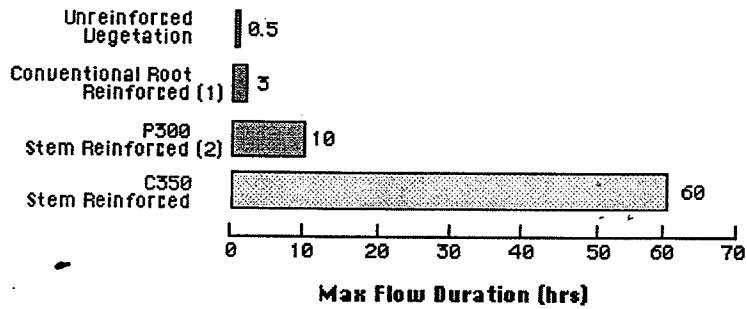
Maximum flow durations for reinforced and unreinforced mature vegetation at 18 feet per second velocity

1. Conventional Root Reinforcement Turf Data from other Manufacturers published data
2. P300 limit reached following at 60 hr flow at 14.5 fps

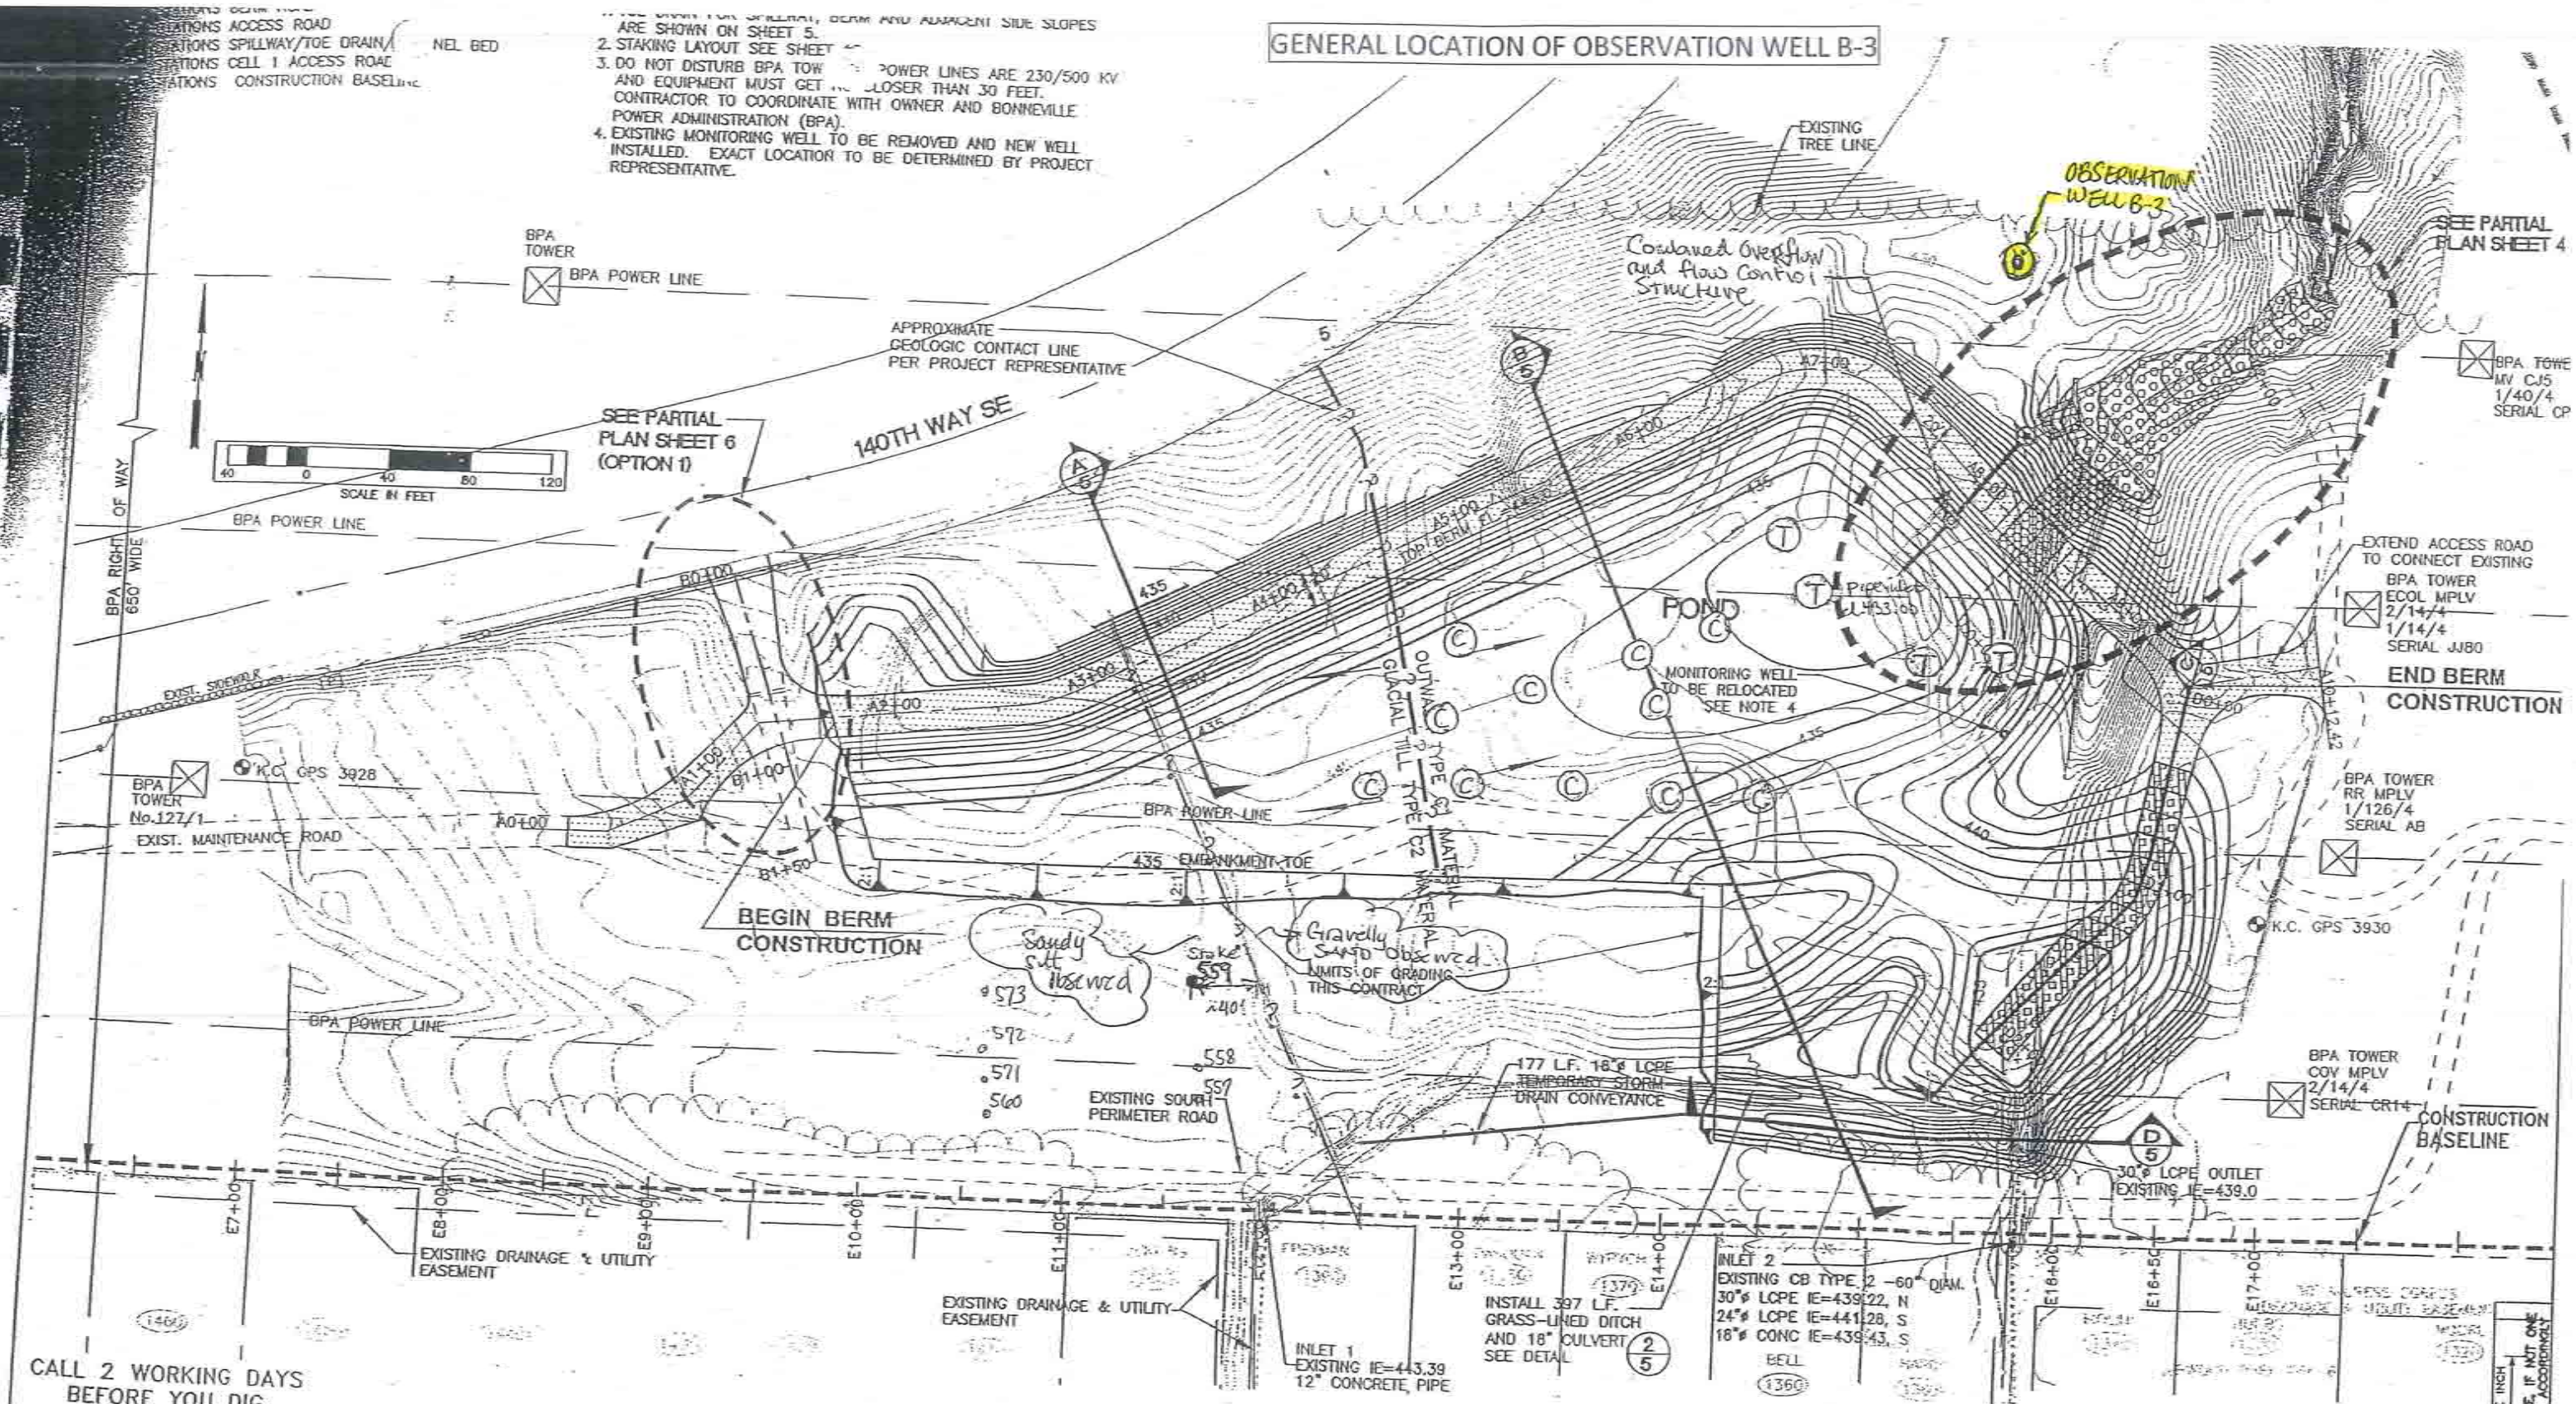
# GENERAL LOCATION OF OBSERVATION WELL B-3

### **Observation Well B-3 Location and Construction Details**
